Town of Franklin
150 Emmons Street
Franklin, MA 02038

August 2003

FRANKLIN WETLAND REPLICATION ASSESSMENT PROJECT

WETLAND REPLICATION ASSESSMENT PROJECT

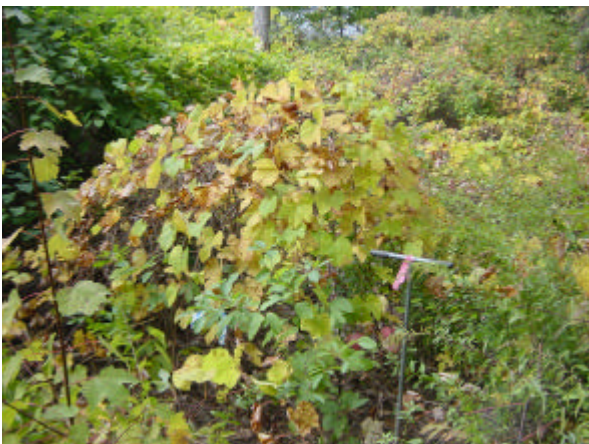
This wetland replication area appears to have been undersized by over 50% based on the approved design plan and observations that the remaining design location was never cleared. Site grading on average appears to be slightly higher in elevation than the adjacent wetland, contributing to inadequate wetland hydrology. The replication area's vegetative community does not exhibit wetland characteristics. The dominant species within the replication were Concord Grape (FACU) and Sassafras (FACU-) with scarce (less than 5 percent) amounts of Canada Golden Rod, Red Maple and Raspberry in the herbaceous layer. The replication area soils do not exhibit hydric characteristics and refusal was consistently reached at around 14 inches. The slopes bordering the replication are dominated by the invasive Japanese Knotweed. However, Japanese Knotweed was scarce within the replication area.

View of replication area monitoring plot, dominated by Concord Grape.

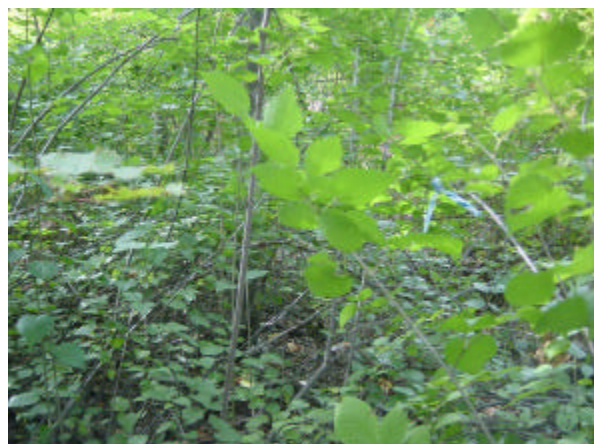
The adjacent wetland community is a forested (predominantly Red Maple) wetland with a thick shrub layer dominated by Northern Arrowwood.

Adjacent wetland monitoring plot 1-w, dominated by Red Maple and Northern Arrowwood.

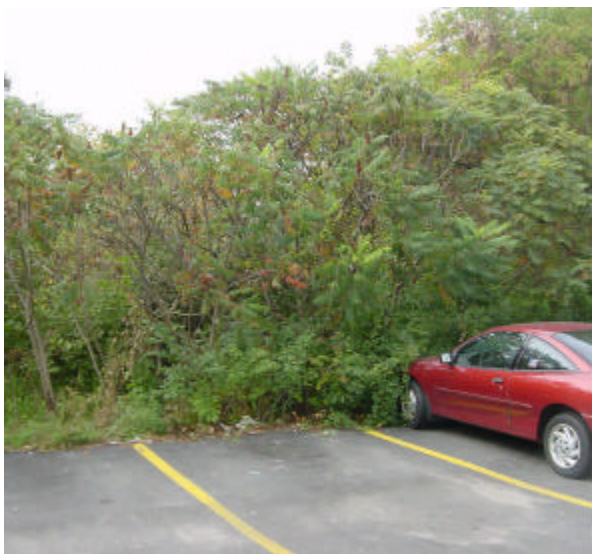
The permitted replication area is dominated by dense growth of mature Staghorn Sumac. Other common species include Wild Raisin, Concord Grape and Virginia Creeper. The area is noticeably upgradient from the adjacent wet meadow area to the west. There is no evidence that the area was ever cleared, graded and seeded with a wetland seed mixture according to the approved plan. The two wetland seed mixture species specified in approved plan were not identified in the replication area.

View of approved replication area

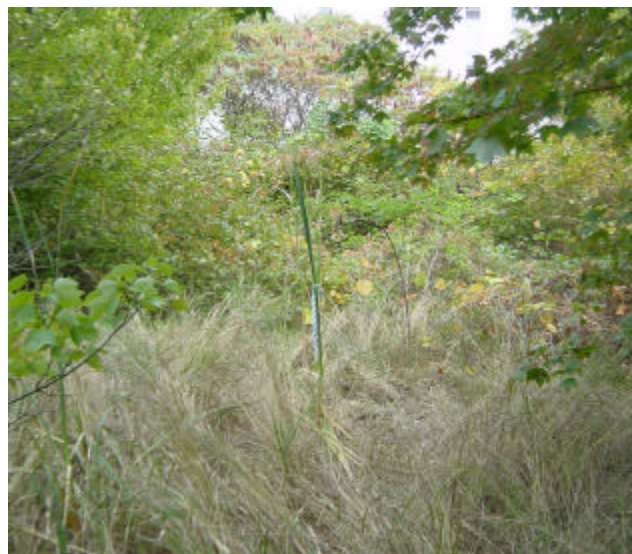
The adjacent wet meadow is dominated by Small Reed Grass and several other herbaceous species such as Broad-leaf Cattail, Skunk Cabbage and Virginia Creeper.

View of adjacent wet meadow monitoring plot 2-w, looking towards approved replication area.

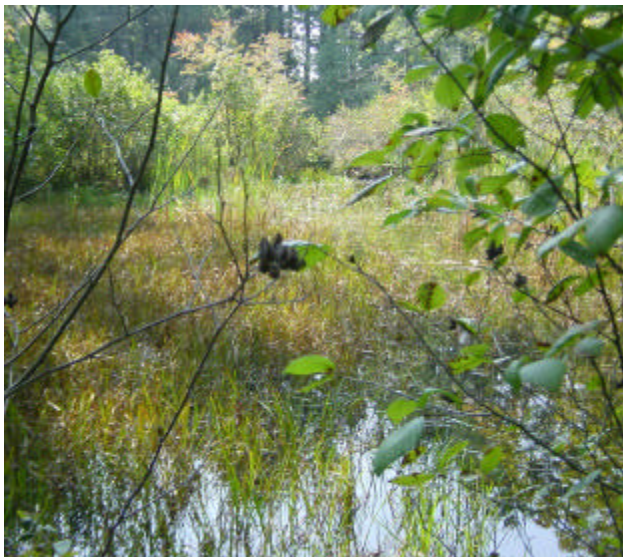
This wetland replication appears to have been well constructed and has ample hydrology to support an emergent wetland community. The replication appears to be functioning very well and is providing excellent wildlife habitat. At the time of inspection, the replication area had 6"-9" of standing water, making it considerably wetter than the adjacent wetland. The replication is dominated by Bur-reed and a variety of other emergent herbaceous species including Narrow-leaved Cattail, Lurid Sedge, Soft Rush, Wool Grass, Three-way Sedge, and Arrowhead. Overall plant densities are moderate, but are expected to increase as the wetland area continues to develop and mature over time. Abundant signs of wildlife use were present, including beaver chewings, muskrat and other mammal paths, and a variety of birds.

Replication area.

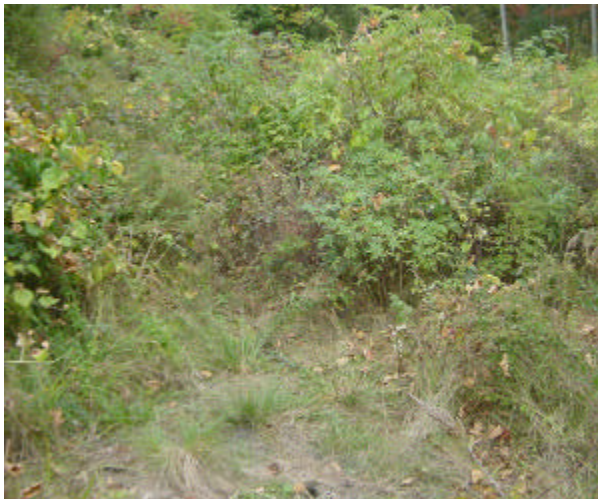
It appears that construction of this replication area did not extend far enough to its approved southern extent, limiting both its size and connection to the adjacent wetland. Overall, the site grading was done poorly and the site is significantly upgradient from the adjacent forested wetland to the southeast. As such, the site hydrology appears to be a limiting factor for the marginal wetland community that has become established. In general, the southeast portion of the site is more successful due to its lower elevation, with more strongly developed hydric soils and a dominant hydric vegetation community including Soft Rush, Spicebush and Elderberry. The northwest end of the site (closer to Washington Street) is upgradient, and has a variety of upland plants such as Staghorn sumac and Concord grape.

Replication area.

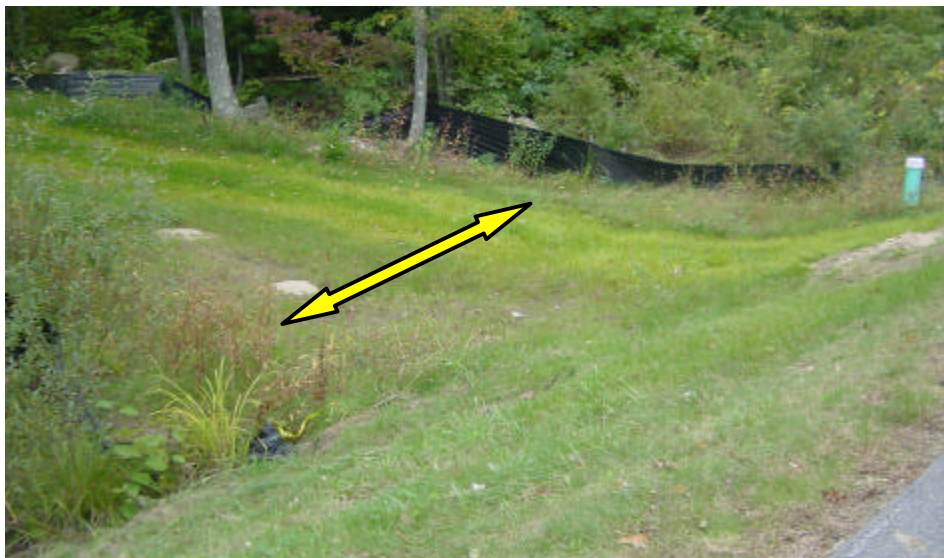
As shown in the photograph below, 67% of this replication area was recently filled in to create a construction access roadway for a project on an adjacent parcel.

View of current vernal pool replication areas and recently filled access road.

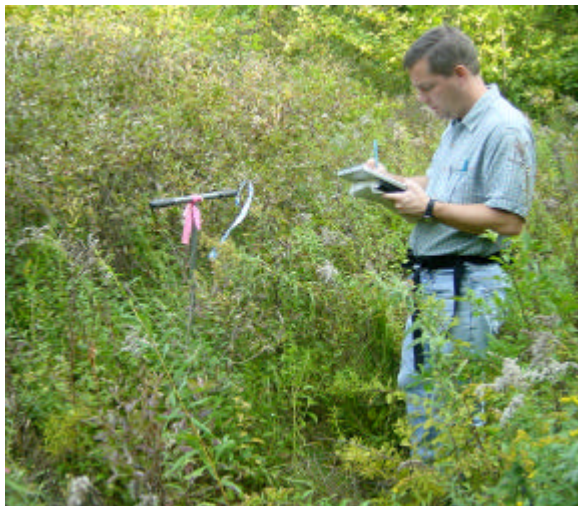
The replication area appears to have been constructed at approximately 50% of its approved size. Soil profiles from the replication area and adjacent wetland were quite similar. However, the adjacent wetland (which is situated downgradient from the replication) had a greater presence of redoximorphic features within the B soil layer, indicating that site grading did not adequately match the replication area's groundwater hydrology to that of the adjacent wetland.

Site grading with the replication was noticeably uneven, with lower elevations (and 'wetter' conditions) found adjacent to the natural wetland boundary. Overall, the constructed portion of the site exhibits a predominantly wetland shrub/herbaceous community with a limited presence of transitional species such as Quaking Aspen and White Pine. Abundant and common species within this area included Canada Goldenrod, Red Osier Dogwood, Broad-leaf Meadowsweet, Broom Sedge, and Poison Ivy. The portion of the replication area that was not constructed is comprised of a cart path and a mowed turf grass area.

Replication Area Monitoring Plot 6-1.

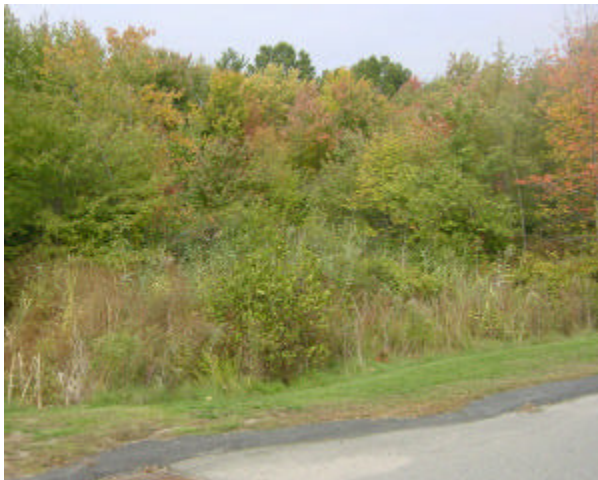
This wetland replication exhibits a diverse and vigorous wetland shrub/herbaceous community, and appears to have been properly graded to ensure appropriate hydrology and connection to the adjacent wetland. Based on the planting locations indicated on the Site Plan, a number of the planted tree and shrub saplings appear to have died, although overall plant density (including “self-selected” wetland species) is quite good. Tree saplings within the area included common growth of Speckled Alder, and a limited presence of other species including Red Maple, Quaking Aspen, and American Elm. Shrub and herb species are too numerous to list, with abundant growth of Tussock Sedge, and the invasive Purple Loosestrife. Other common plants included Northern Arrowwood, Virginia Creeper, Arrowleaf Tearthumb, Jewelweed, and Common Reed. Soils within the replication had well-developed hydric soil characteristics, with a very dark, mucky A layer and significant redoximorphic features within the top seven inches.

View of replication area from Highland Street.

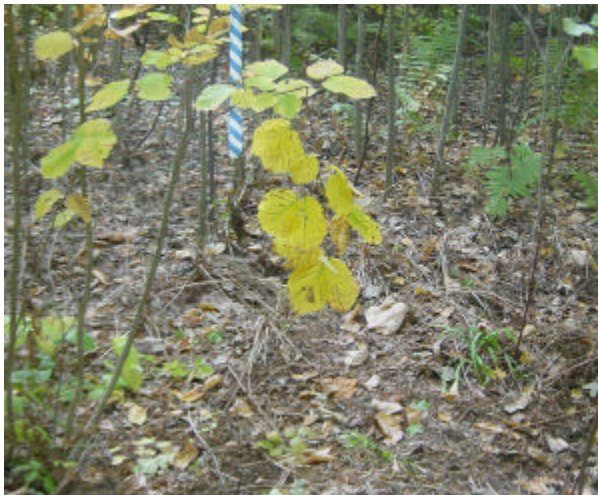
This replication area is functioning only marginally well as a wetland due to inadequate grading, which limits its supporting hydrology. Indicative of the site’s marginal wetland status is the presence of transitional species in the tree, sapling and shrub layers, such as Eastern Cottonwood, Grey Birch, Quaking Aspen Red Oak, Witch Hazel, and White Pine. However, the herb layer was dominated by hydrophytic vegetation including Cinnamon Fern, Highbush Blueberry, and Tussock Sedge. By comparing the overall wetland community with that of the adjacent wetland, it appears as though grading to a slightly lower elevation would have yielded a more predominantly wetland vegetation community and increased wetland functions.

Replication monitoring plot 8-1.

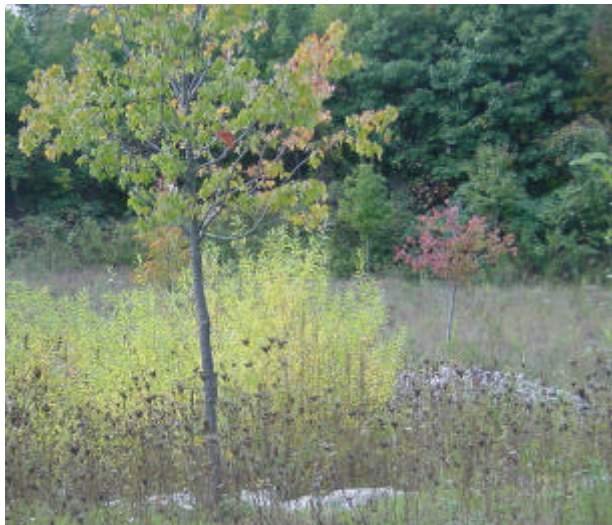
Despite being undersized by roughly 4,500 square feet, this replication area appears to be functioning well as a predominantly herbaceous wet meadow. Twenty-four healthy Red maple saplings (and one dead sapling) were counted within the replication area, as well as lesser number of River Birch, Arrowwood, Grey Birch and Speckled Alder. The diverse herb layer within the monitoring plot was dominated by Soft Rush, Wool Grass, Tussock Sedge, and Blue Vervain. Other common species outside of the plot included New York Ironweed, Sensitive Fern, Lurid Sedge and Joe-Pye Weed. The replication also exhibited well-developed hydric soils, with significant redoximorphic features within the top six inches of the A layer.

View of replication area from access roadway off of Tanglewood Drive.

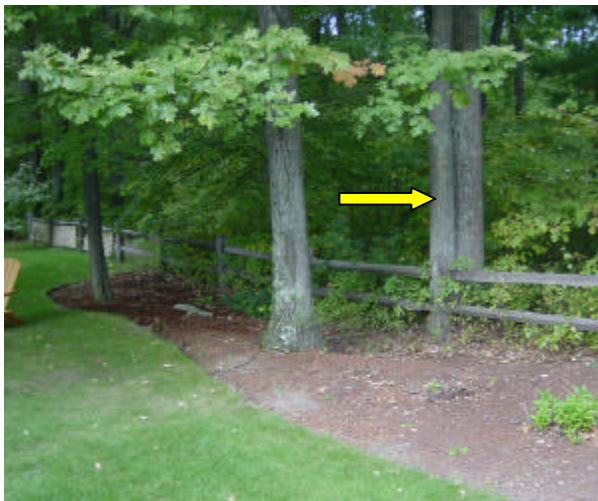
It appears that this wetland replication was never constructed. The project associated with the replication area involved filling wetlands and installing a 16-inch pipe to replace a section of drainage channel. The replicated wetland was to be constructed roughly parallel to the western edge of the property at 7 Oak Tree Lane (off-set approximately 15 feet from the property boundary). Field measurements from the wetland boundary (original flags were observed) revealed that the approved replication area is currently forested with medium diameter trees, having never been cleared, graded, or planted to replicate wetland conditions.

Approved wetland replication area.

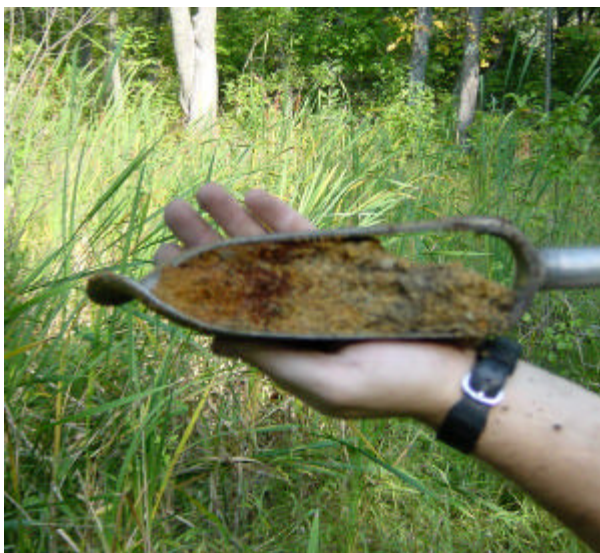
This replication area seems to be thriving as an intermittently flooded wet meadow community. At the time of the site inspection, most of the 30 shrubs specified in the planting plan were either found dead or absent from the replication area. Two Red Maples and Two Highbush Blueberry plantings were still alive. It is possible that the shrub plantings did not survive because the site is too wet for these species to thrive. Regardless, this replication can certainly be considered a success based on the health and vigor of its wetland herbaceous community, the habitat it provides, and its flood storage functions. The site exhibits well-developed hydric soils, with significant redoximorphic features within the top 12 inches (see photo below). Common plants include Canada rush, Soft Rush, Spike Rush, and Pennsylvania Smartweed.

Replication monitoring plot 11A-1, exhibiting strongly developed hydric soils.

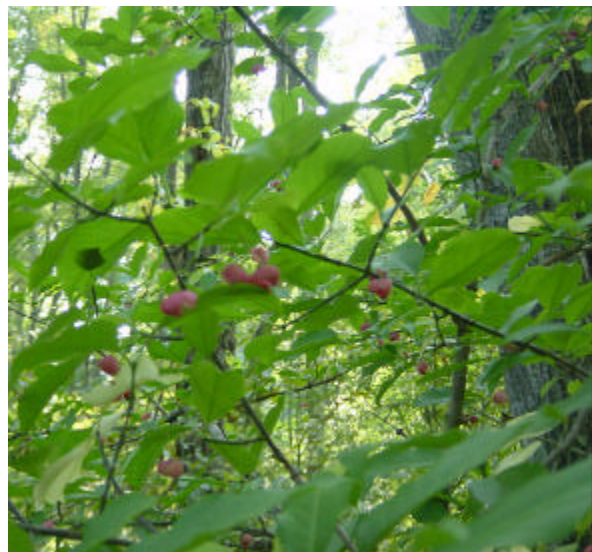
Adjacent wetland monitoring plot area, showing Eastern Burning Bush.

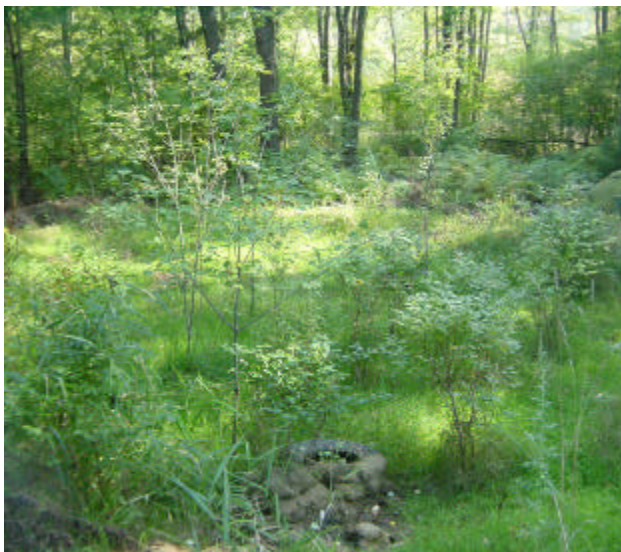
This replication area appears to be thriving, as is particularly notable for the survival rate and vigor of its planted trees and shrubs. Based on a comparison of site conditions with the approved planting plan, it appears that all of the planted shrubs/trees are alive and well established, as seen in the photo below. As expected from the planting plan, saplings and shrubs at the site include Red Maple, Highbush Blueberry, and Northern Arrowwood. The herbaceous community is dominated by one wetland species (Soft Rush, FACW+) and one facultative upland species (Autumn Bent Grass, FACU). Swamp Buttercup is also common. Hydric soils are present at the site.

Replication area 11-B. Planted trees and shrubs appear to be thriving.

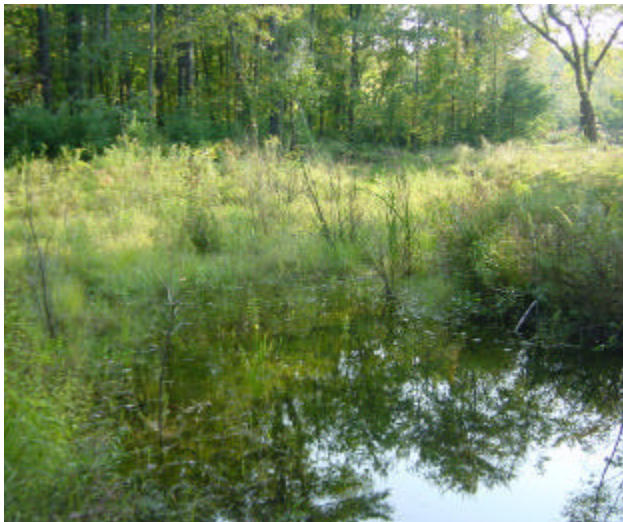
This outstanding replication area provides excellent wildlife habitat and flood storage functions. Most of the area hosts a diverse and thriving emergent herbaceous wetland community, with some areas that appear to be permanently flooded. Similar to site 11-A, a significant percentage of the 75 planted shrubs/trees indicated on the planting plan appear to have failed, possibly due to conditions being too wet for their survival. However, sixteen herbaceous wetland species were found growing densely in the area around the monitoring plot, including Wool Grass, Soft Rush, Water Starwort, Marsh Seedbox, Pennsylvania Smartweed, and Swamp Loosestrife.

Replication area 11-C.

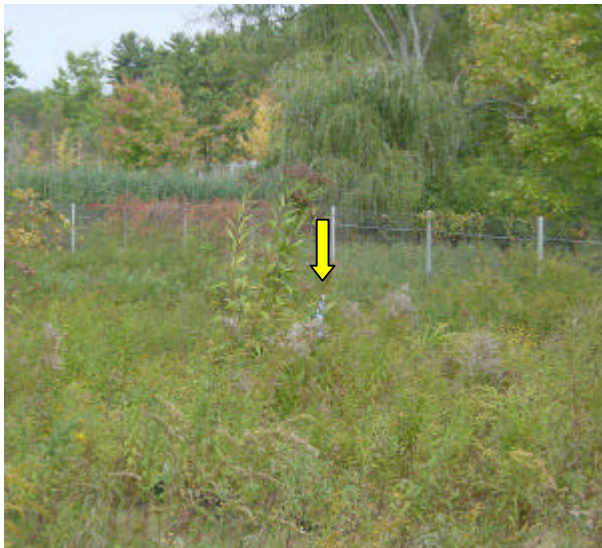
This site is a small wetland restoration area that was constructed by removing improperly placed fill material and replanting with wetland species. Overall, the restoration area appears to have been constructed properly, although it was graded to a slightly higher elevation than that of the adjacent wetland. As a result of this higher elevation, the common plants within the herbaceous community are more characteristic of a transitional wetland. Common plants included Canada Goldenrod (FACU), Wrinkled Goldenrod (FAC), New York Ironweed (FACW) and Fragrant Goldenrod (FAC) and Common Sneezeweed (FACW+).

Replication monitoring plot 12-1.
